# **Geology and Preliminary Hydrogeologic Characterization of the Cell-House Site, Berlin, New Hampshire, 2003-04**

Scientific Investigations Report 2004-5282

**U.S. Department of the Interior  
U.S. Geological Survey**

By James R. Degnan, Stewart F. Clark, Jr., Philip T. Harte, and Thomas J. Mack

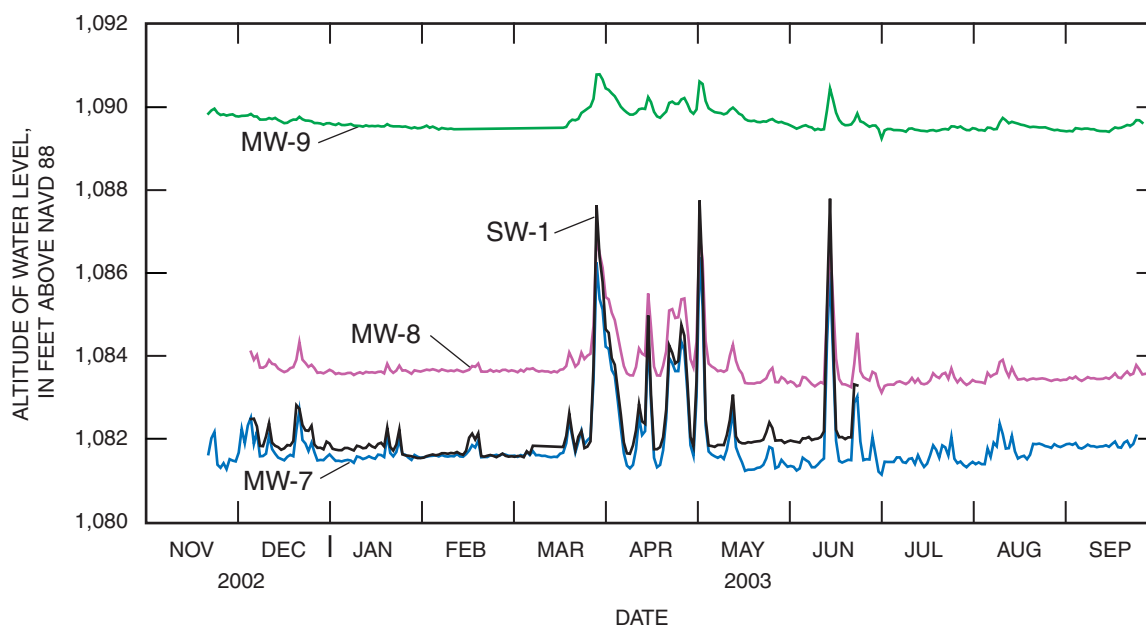
**Figure 22.** Average daily water levels from bedrock wells MW-7, MW-8, and MW-9 and river stage from surface-water measuring point SW-1 at the cell-house site, Berlin, N.H. (Location of sites shown on figure 2.)

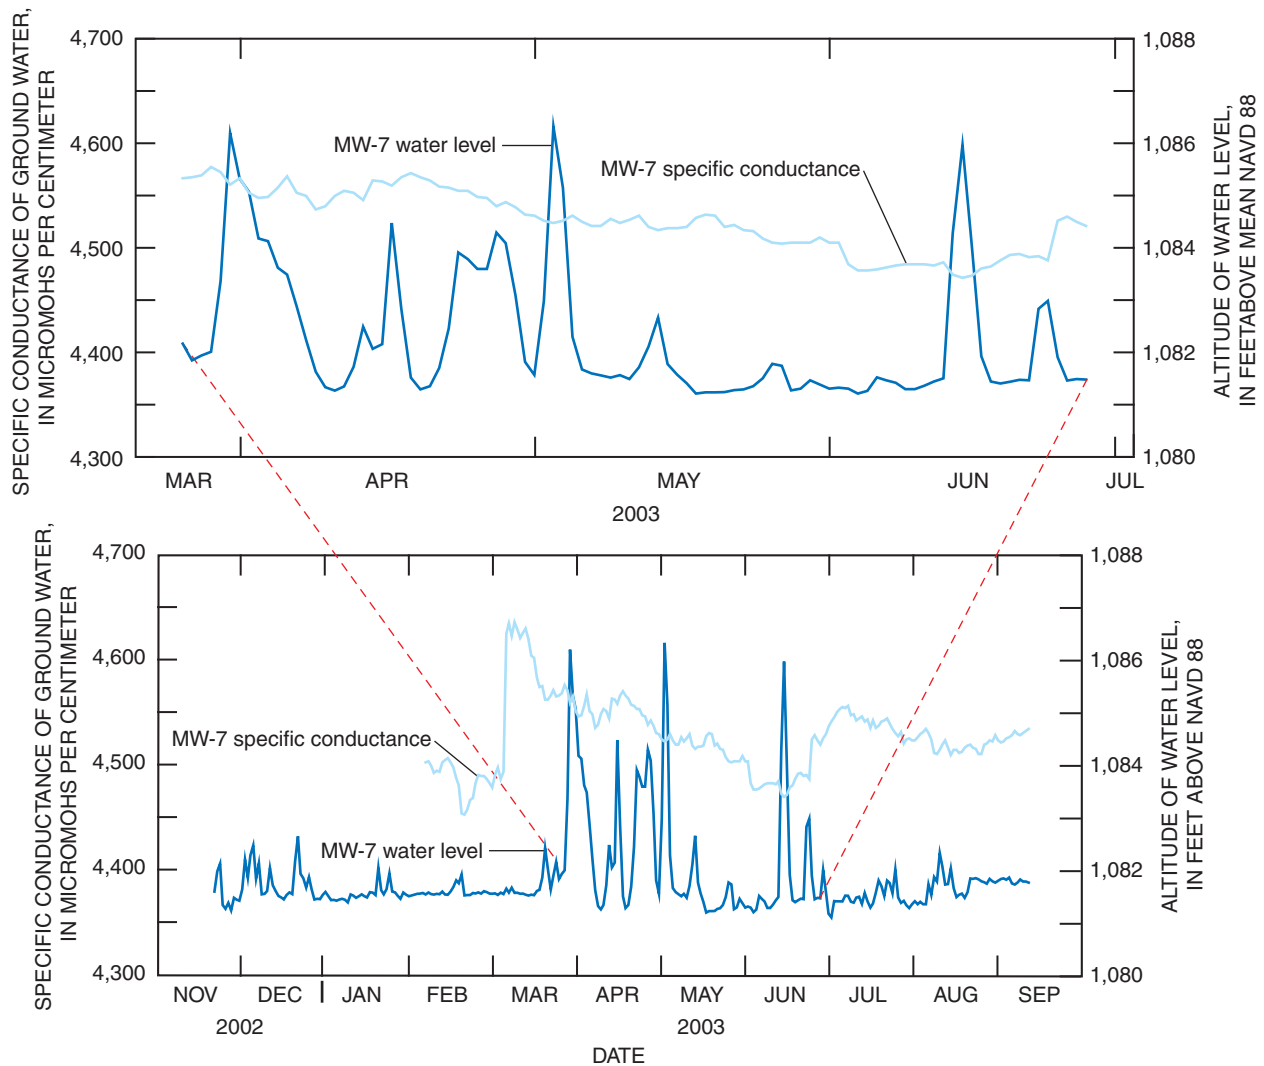
**Figure 23.** Average daily water levels and specific conductance at well MW-7 at the cell-house site, Berlin, N.H.

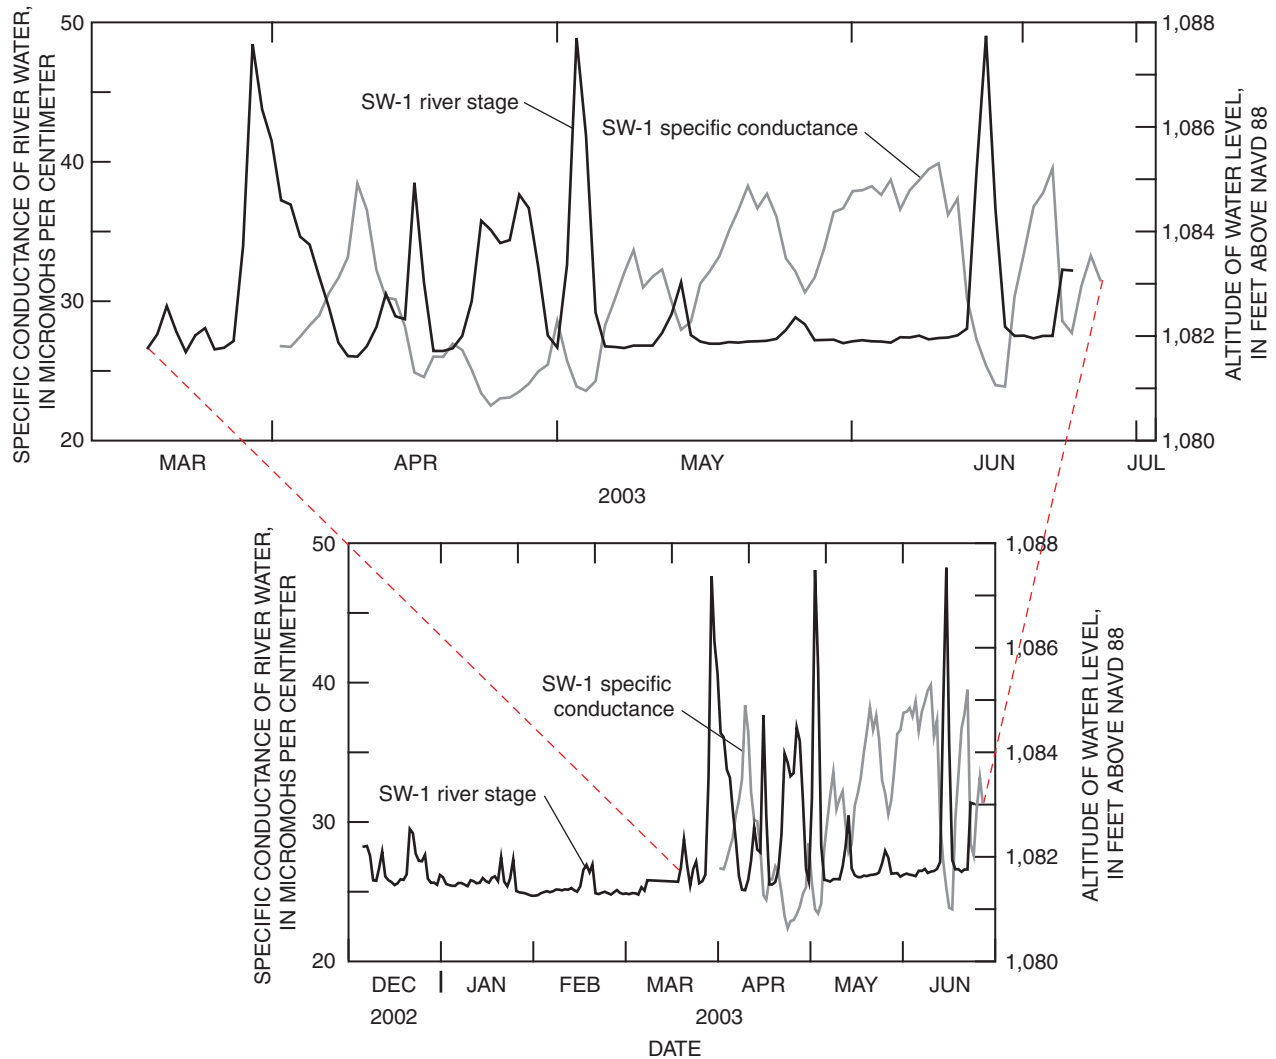
**Figure 24.** Average daily stage at SW-1 and specific conductance in the Androscoggin River at the cell-house site, Berlin, N.H.

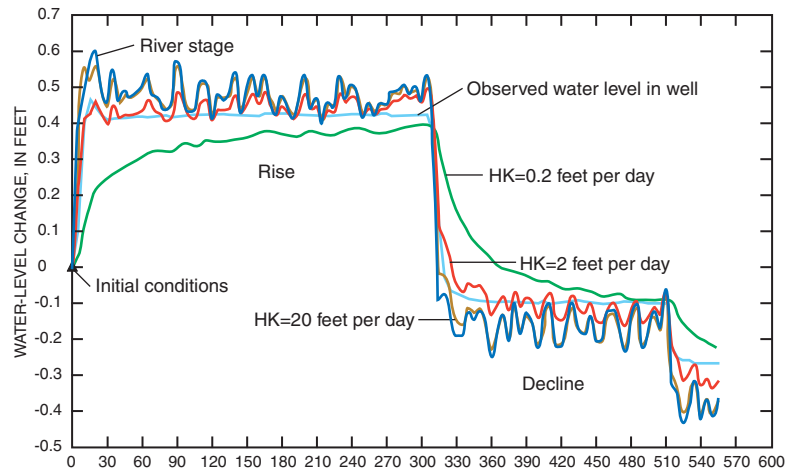
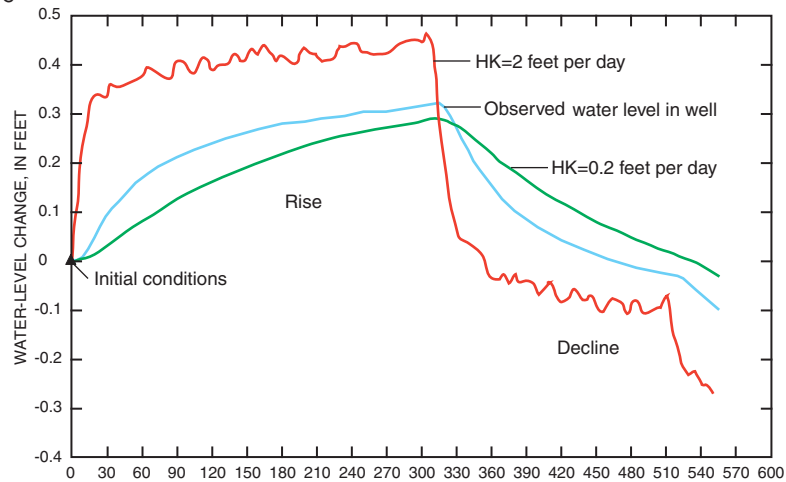
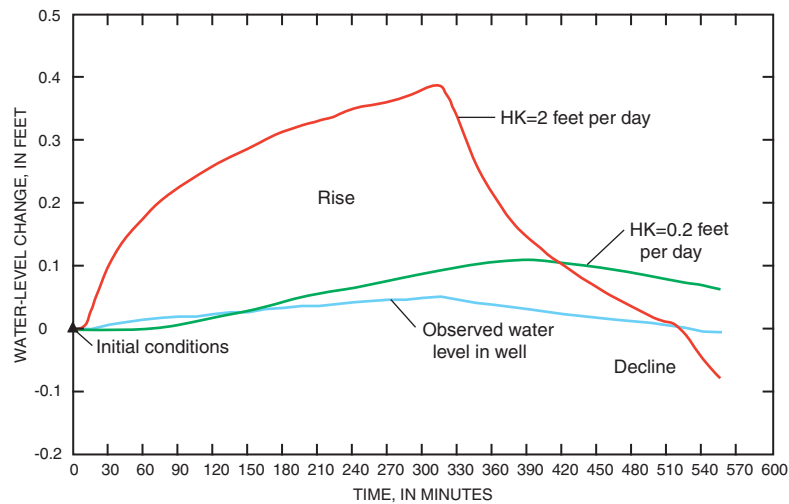
**Figure 26.** Observed water levels and computed water levels for the assigned horizontal hydraulic conductivity (HK) in response to river stage changes for bedrock wells (A) MW-7, (B) MW-8, and (C) MW-9 on April 3, 2003, cell-house site, Berlin, N.H. (Location of wells shown on figure 2.)

River stage and simulated head fluctuations indicate that the bulk horizontal hydraulic conductivity of the bedrock, between MW-7 and the river, is one to two orders of magnitude greater than between MW-8 and the river and MW-9 and the river (table 4). A reasonable calibration was obtained

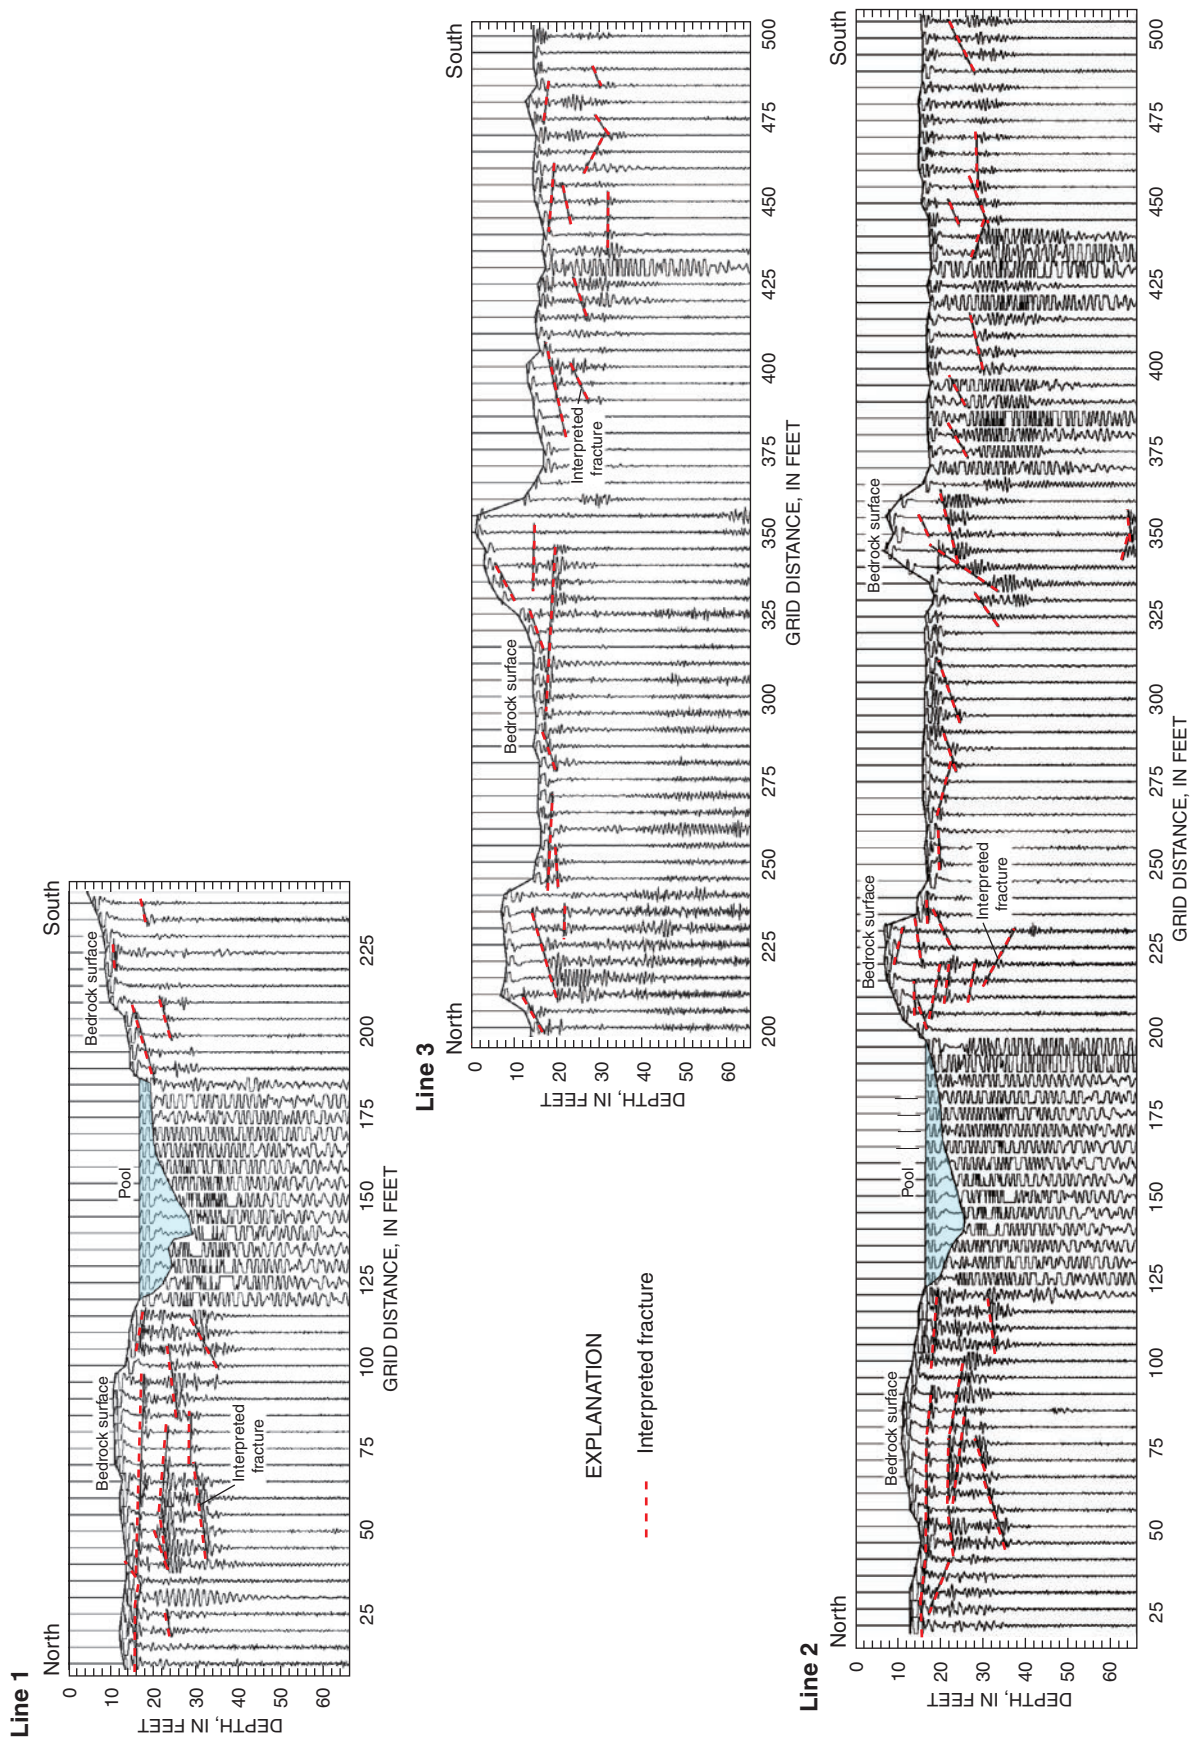
**Figure 27.** Ground-penetrating-radar profiles and interpretations from lines 1, 3, and 2 on the bank of the Androscoggin River, Berlin, N.H. (Location of lines shown on figure 2.)

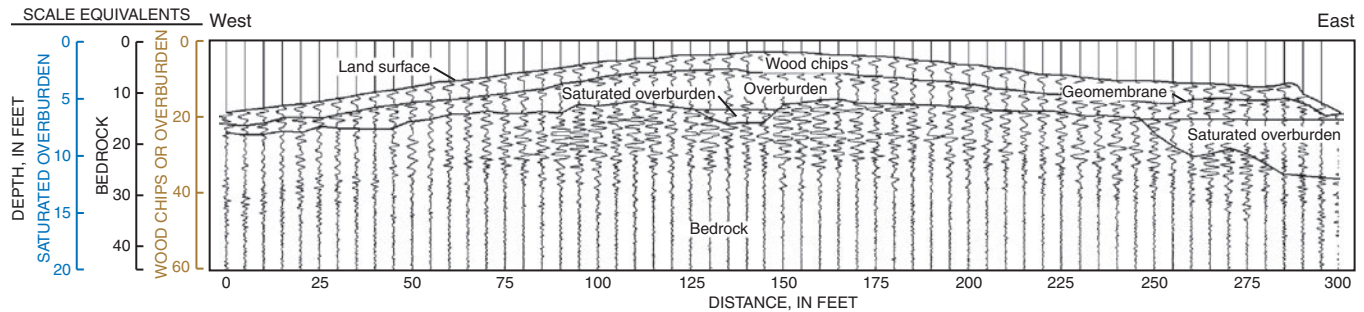
**Figure 28.** Ground-penetrating radar profiles from line 26 on the capped area of the cell-house site, Berlin, N.H. (Depth scale is material dependent. Location of line shown on figure 2.)

GPR surveys were used on the capped area to identify depressions in the bedrock surface and potential fracture zones. Interpretation of GPR profiles was difficult because it was not possible to distinguish unknown debris in the overburden material from geologic features. However, four layers are presented for line 26 (fig. 28) that were interpreted from reflections in the GPR profile: (1) woodchips and geomembrane cap, 3–4 ft thick; (2) overburden, 3–10 ft thick; (3) saturated overburden, 0–5 ft thick and (4) bedrock. Shallow depths to bedrock are confirmed through soil-boring data and observations of outcrops adjacent to the capped area. There is a 2-ft-deep depression in the surface of the bedrock, relative to surrounding areas, between 130 and 150 ft along line 26 (fig. 28) that could be the result of a fractured bedrock surface.

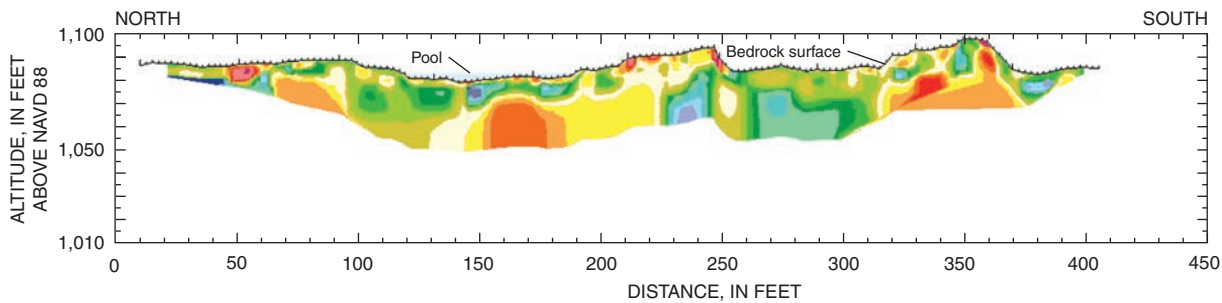
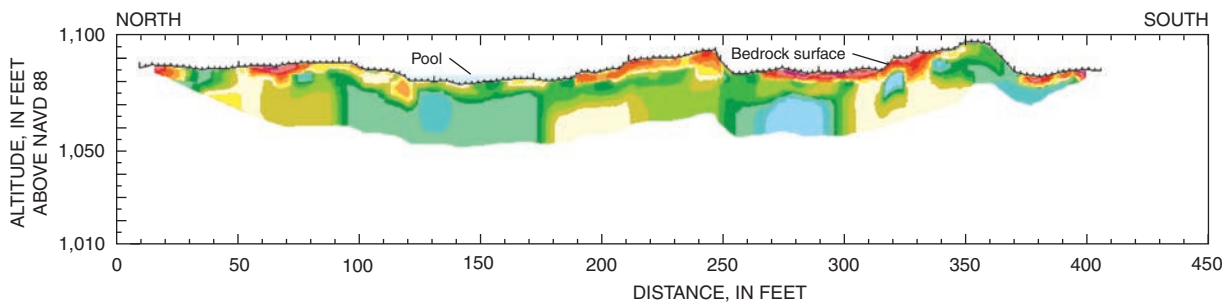
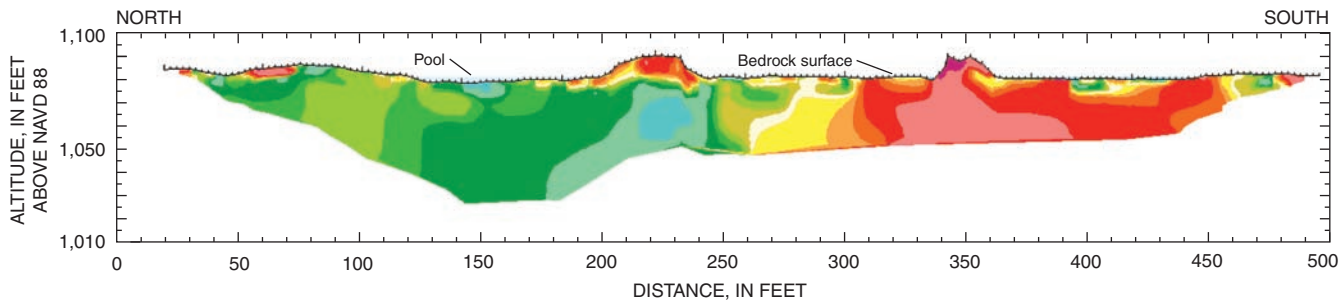
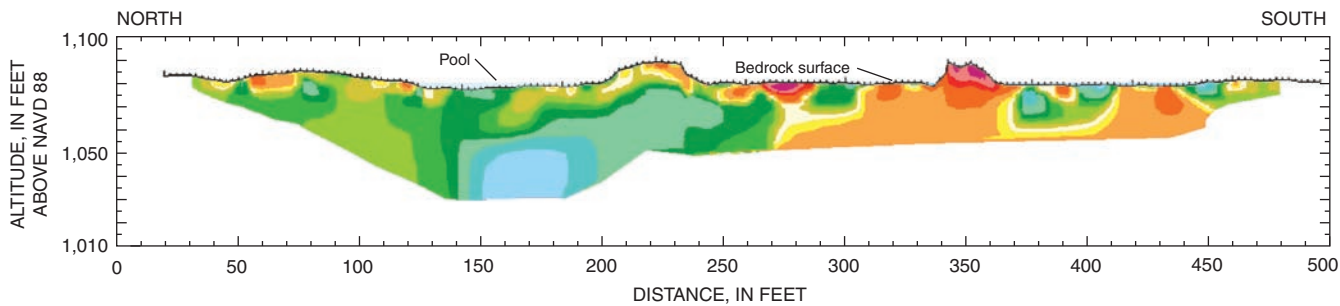
**Figure 29.** Resistivity profiles from lines 1 and 2 on the bank of the Androscoggin River, cell-house site, Berlin, N.H. (Location of lines shown on figure 2.)

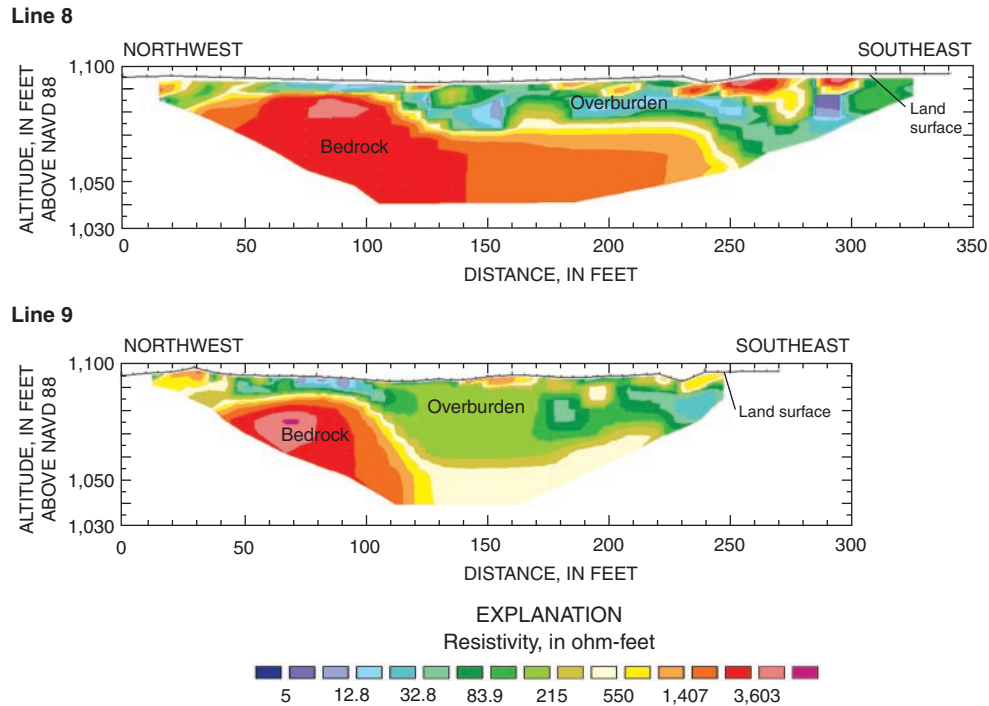
**Figure 30.** Resistivity profiles showing dipole-dipole array from lines 8 and 9 on the southwestern perimeter of the cell-house site, Berlin, N.H. (Location of lines shown on figure 2.)

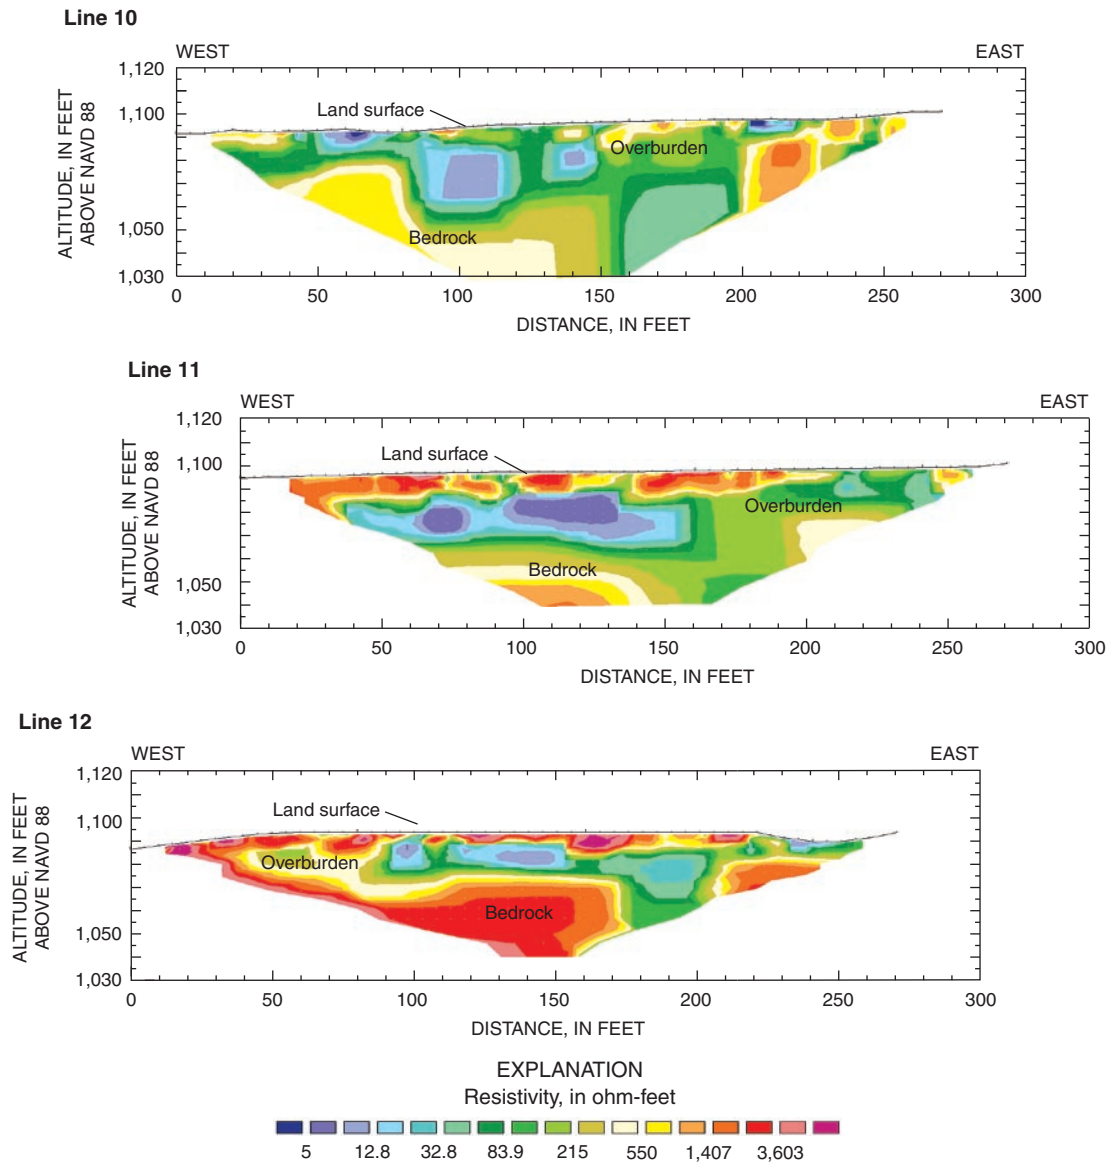
**Figure 31.** Resistivity profiles showing dipole-dipole array from lines 10, 11, and 12 on the southern perimeter of the cell-house site, Berlin, N.H. (Location of lines shown on figure 2.)

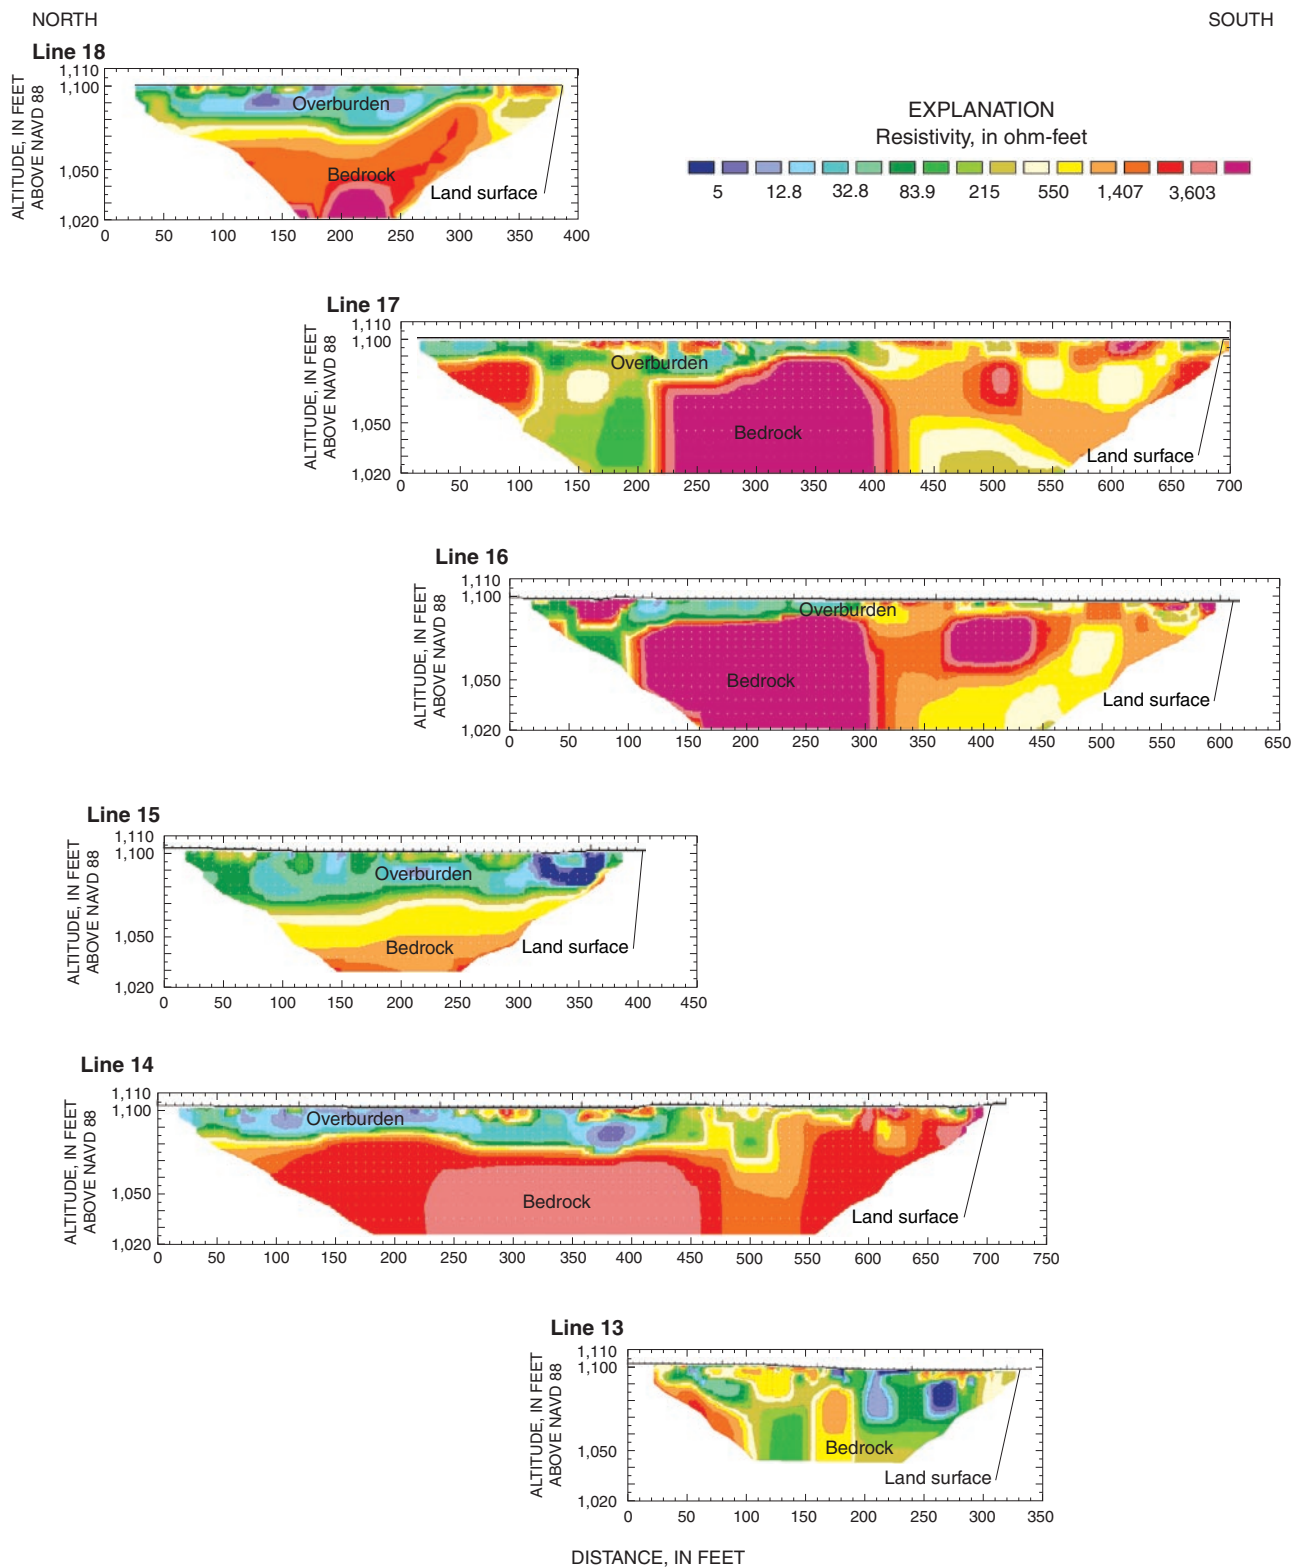
**Figure 32.** Resistivity profiles showing dipole-dipole array from lines 13 through 18 on the eastern perimeter of the cell-house site, Berlin, N.H. (Location of lines shown on figure 2.)

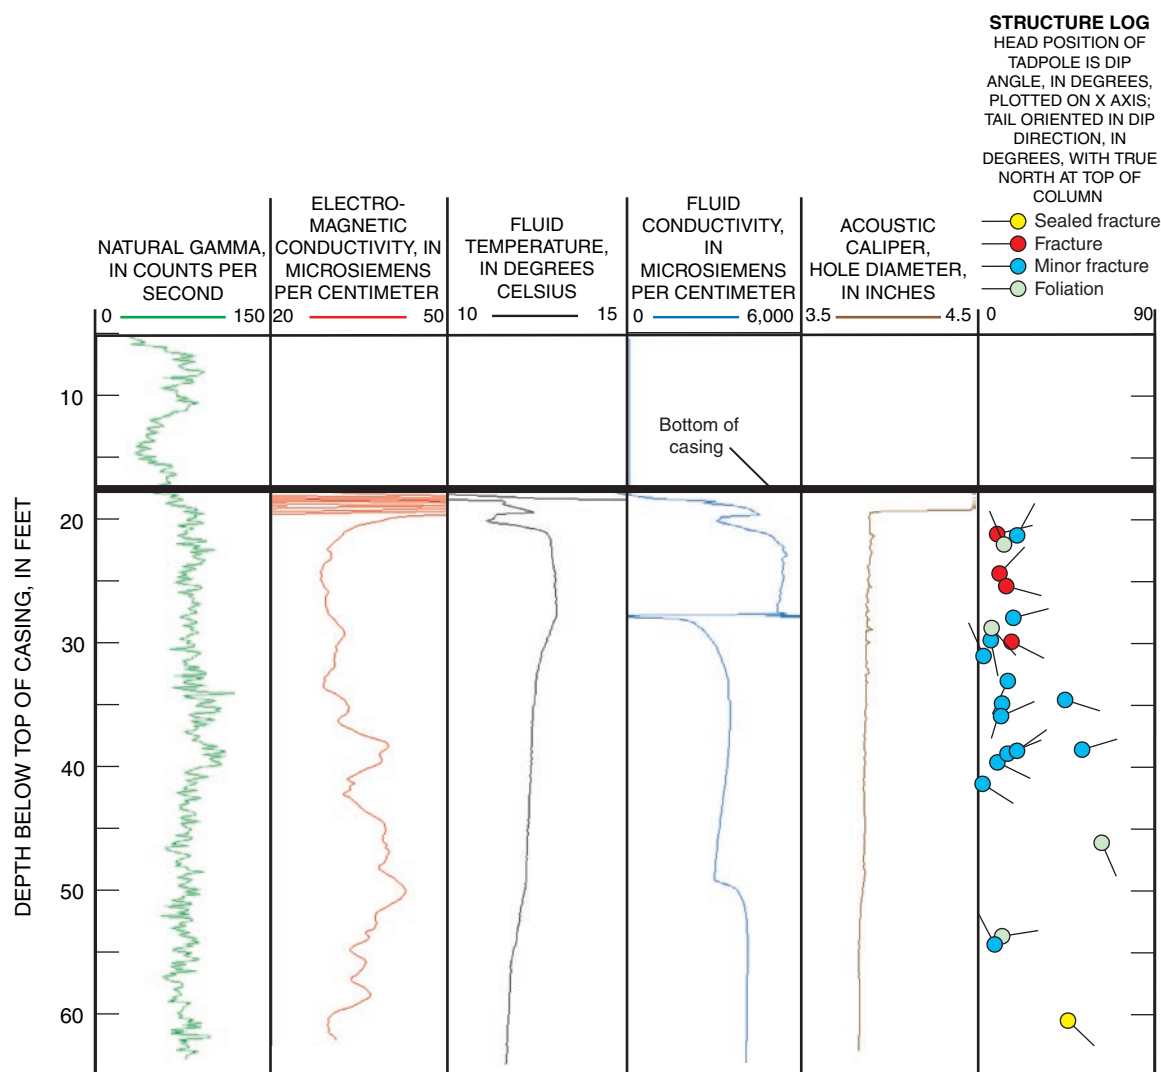
**Figure 33.** Borehole-geophysical logs of well MW-14, cell-house site, Berlin, N.H. (Location of well shown on figure 2.)

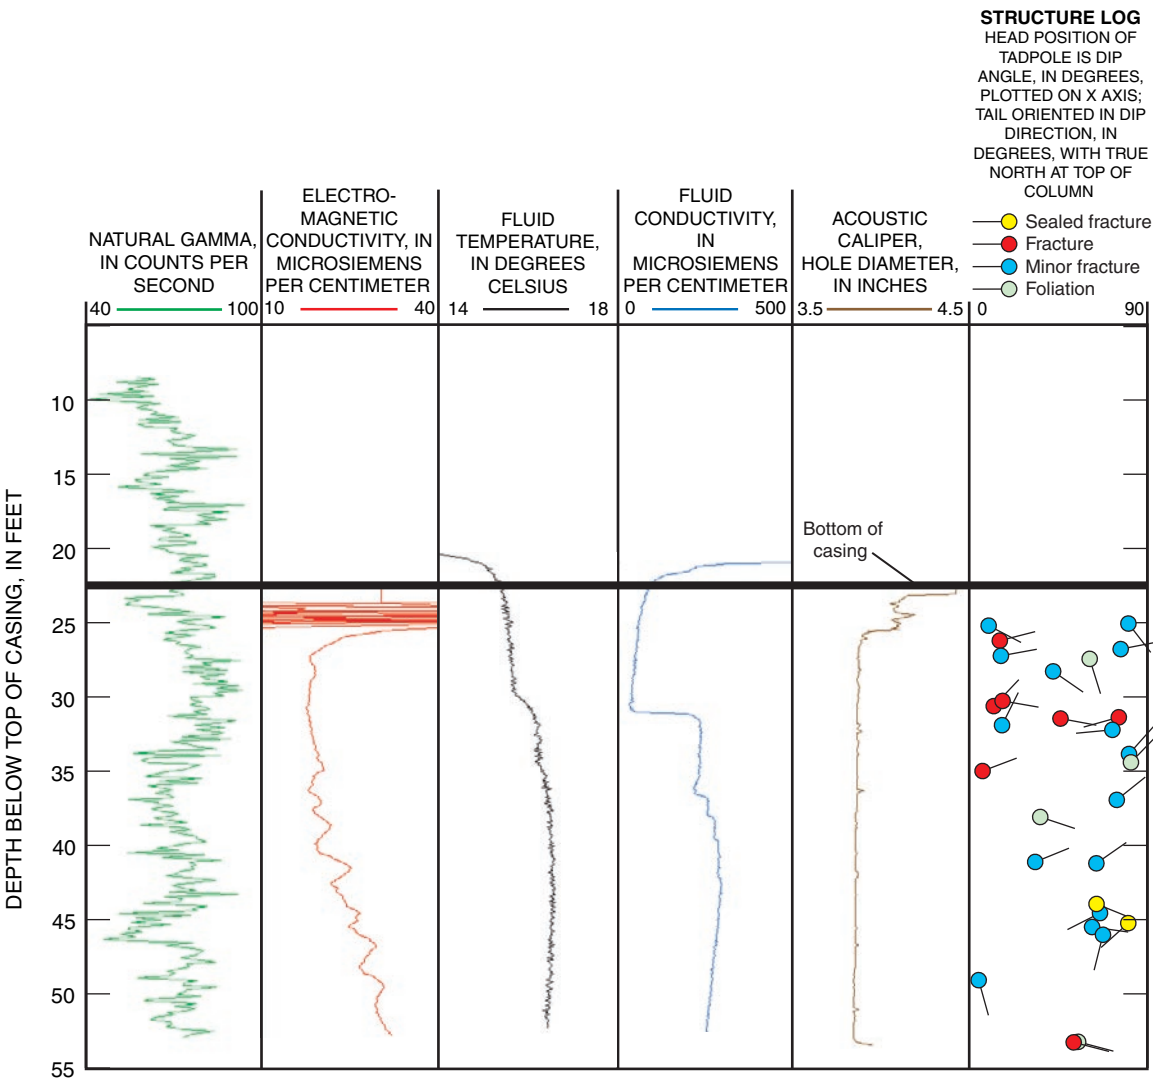
**Figure 34.** Borehole-geophysical logs of well MW-15, cell-house site, Berlin, N.H. (Location of well shown on figure 2.)

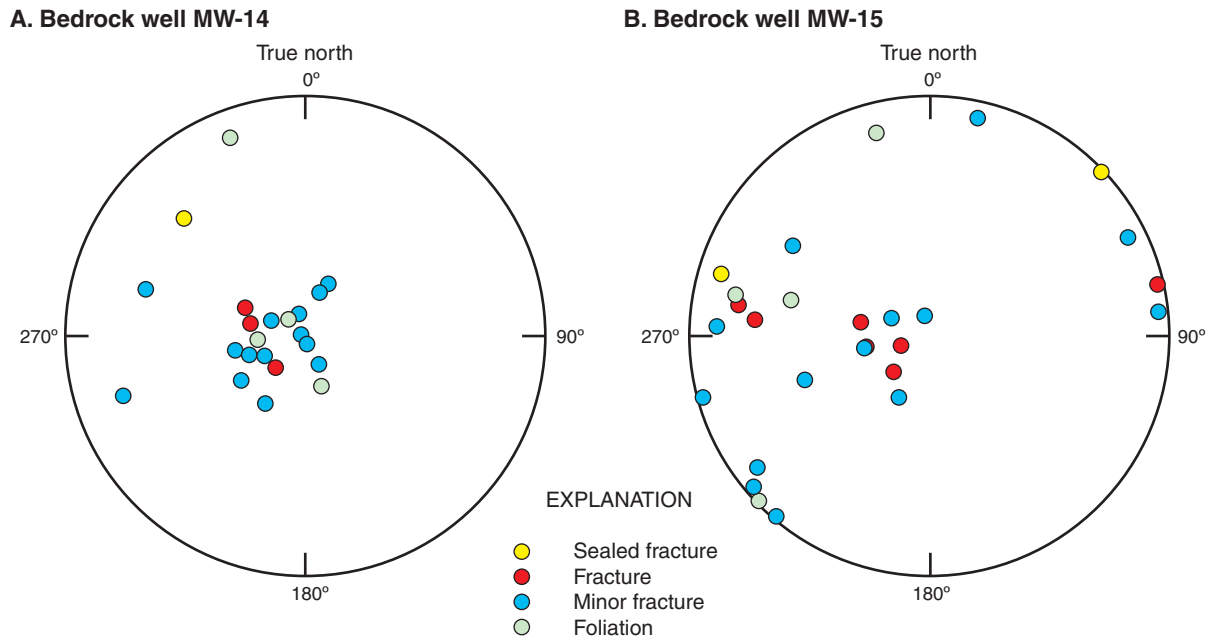
**Figure 35.** Lower hemisphere stereonet projections showing orientation with poles to plane of bedrock structure in wells (A) MW-14 and (B) MW-15, cell-house site, Berlin, N.H. (Location of wells shown on figure 2.)

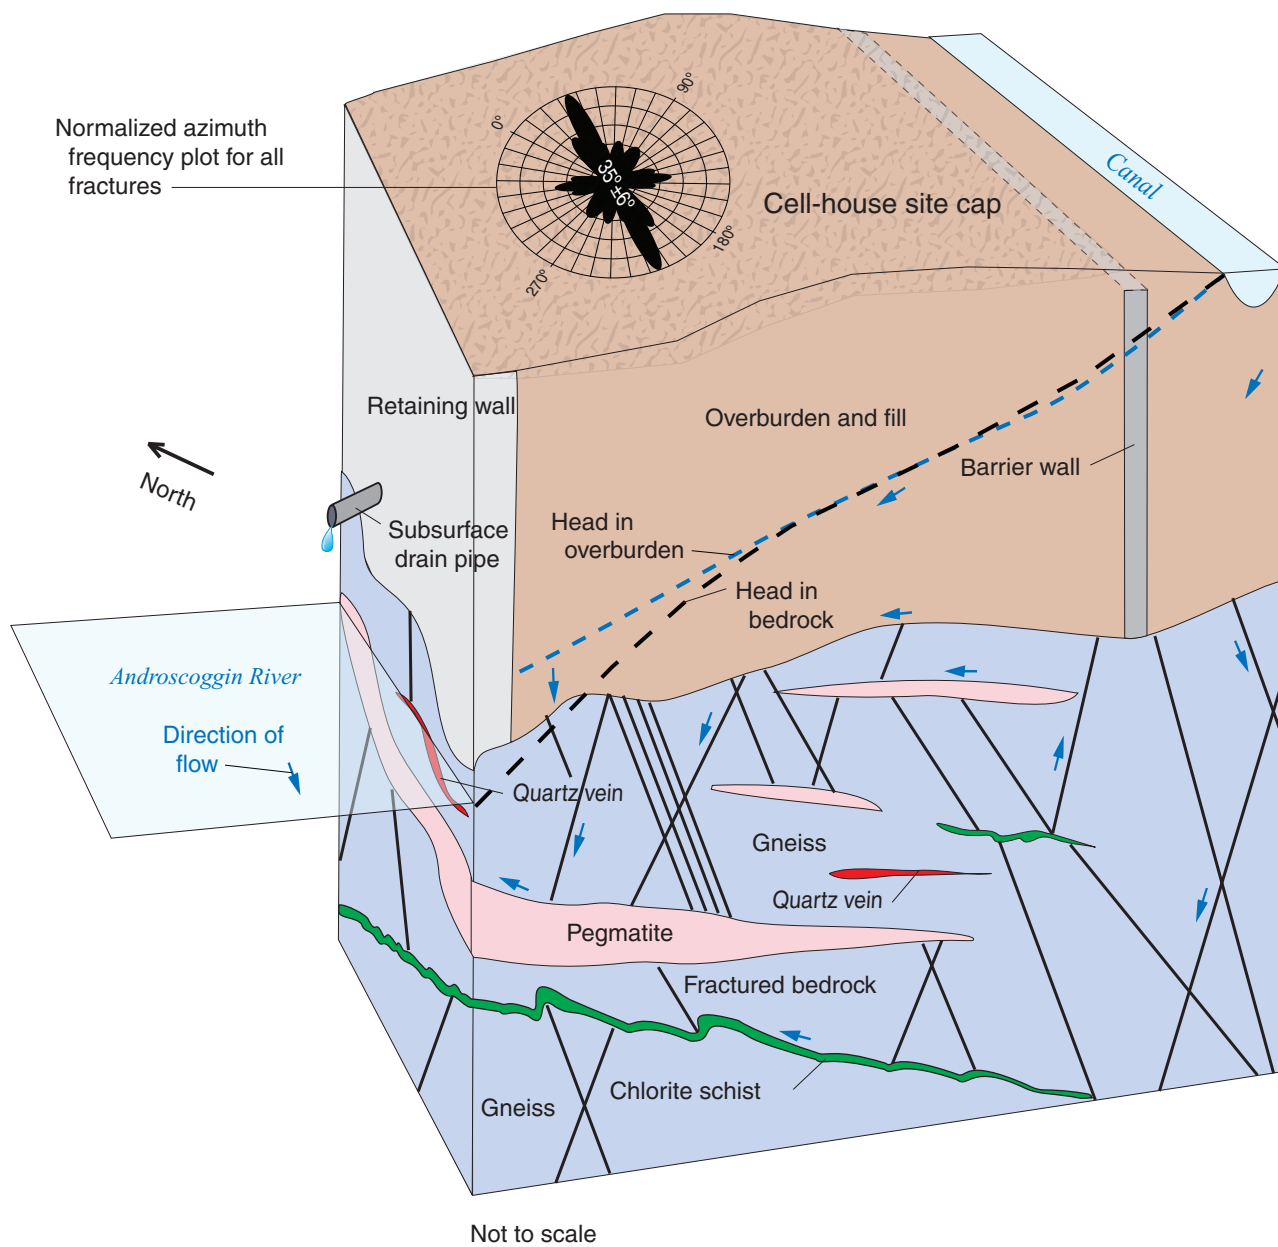
**Figure 36.** Conceptual model of the hydrogeology at the cell-house site, Berlin, N.H.

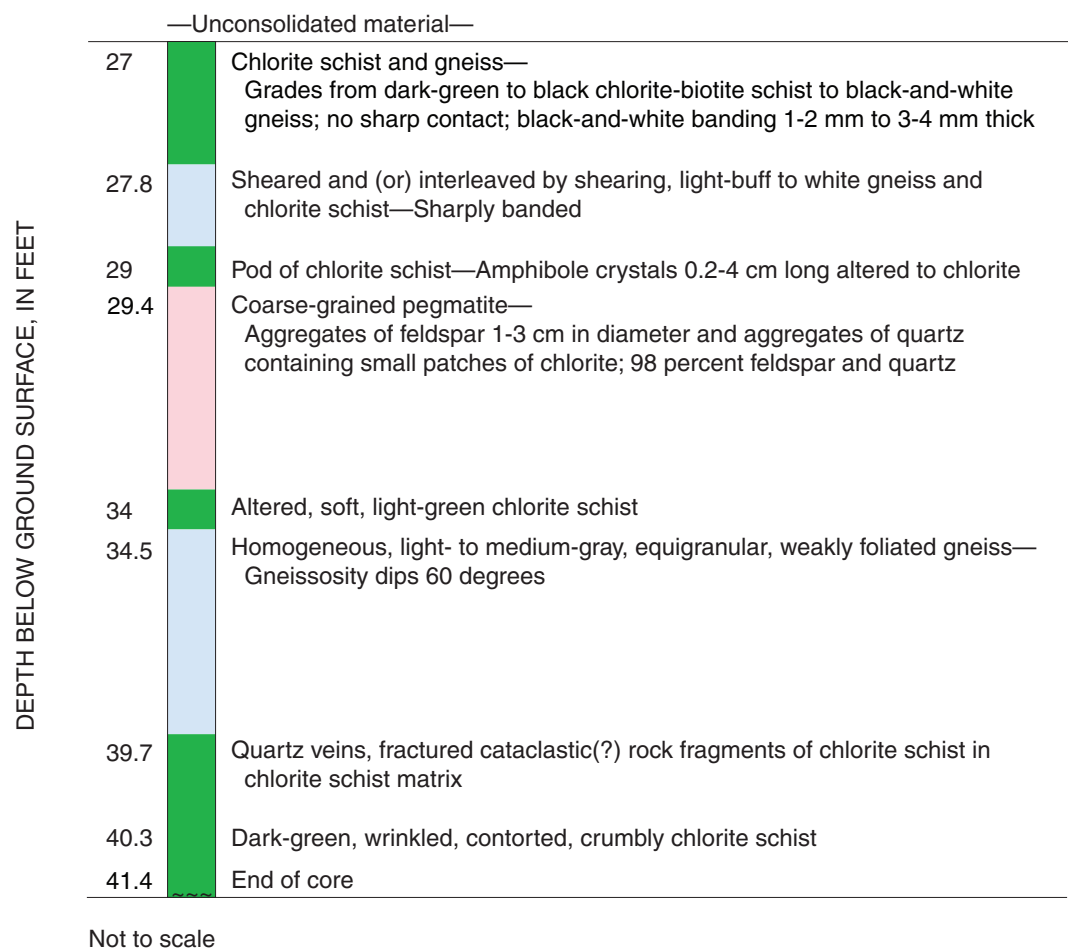
Figure 1–1. Core log from borehole at bedrock well B-4A, cell-house site, Berlin, N.H.

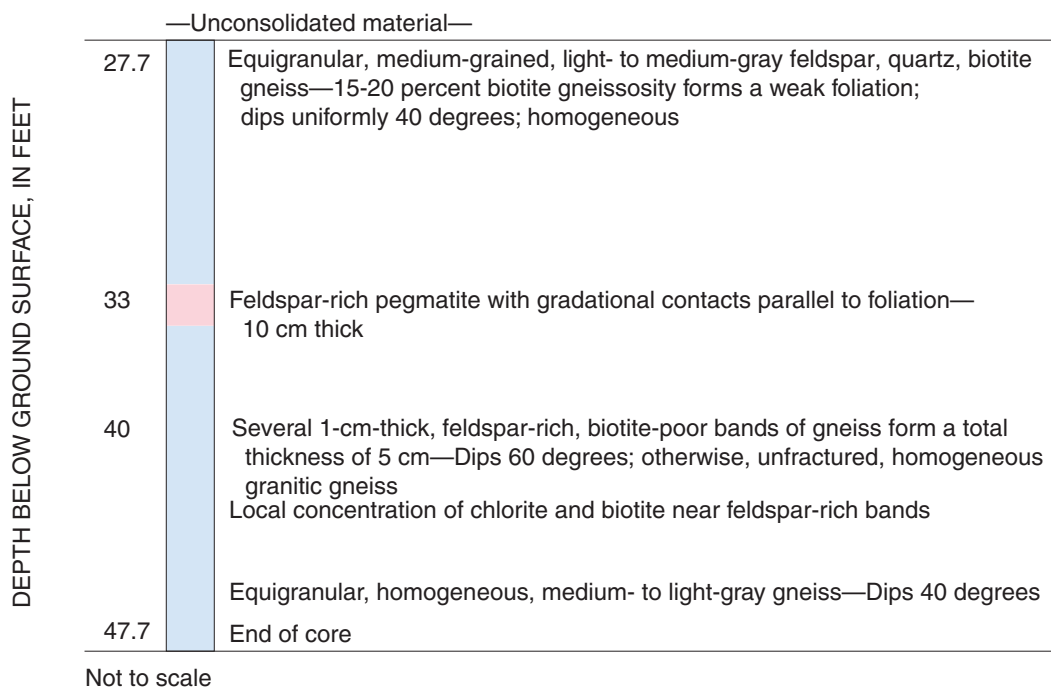
**Figure 1–2.** Core log from borehole at bedrock well MW-4AR, cell-house site, Berlin, N.H.

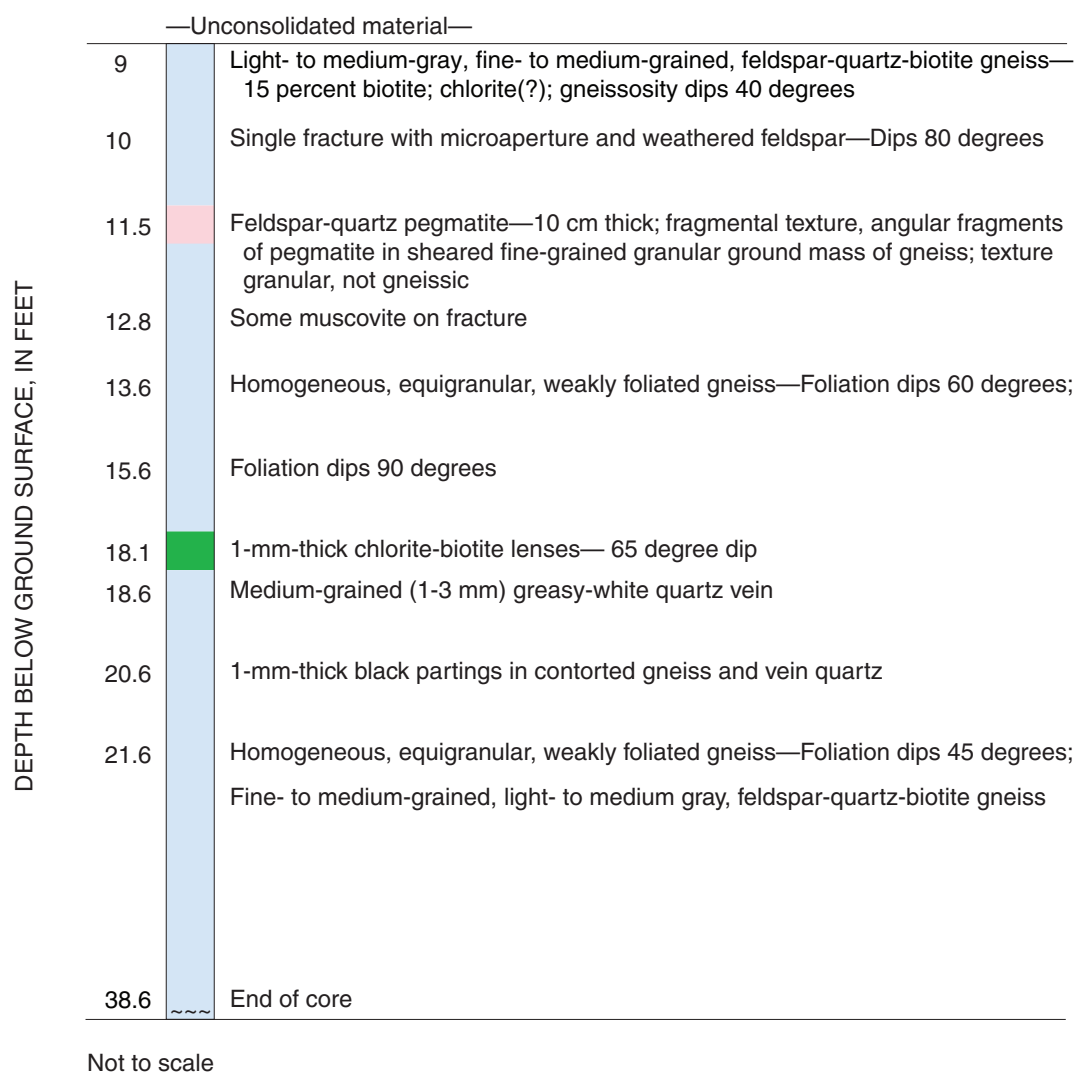
**Figure 1-3.** Core log from borehole at bedrock well MW-7, cell-house site, Berlin, N.H. (See figure 2 for location of well and plate 1 for structure and distribution of rock types.)

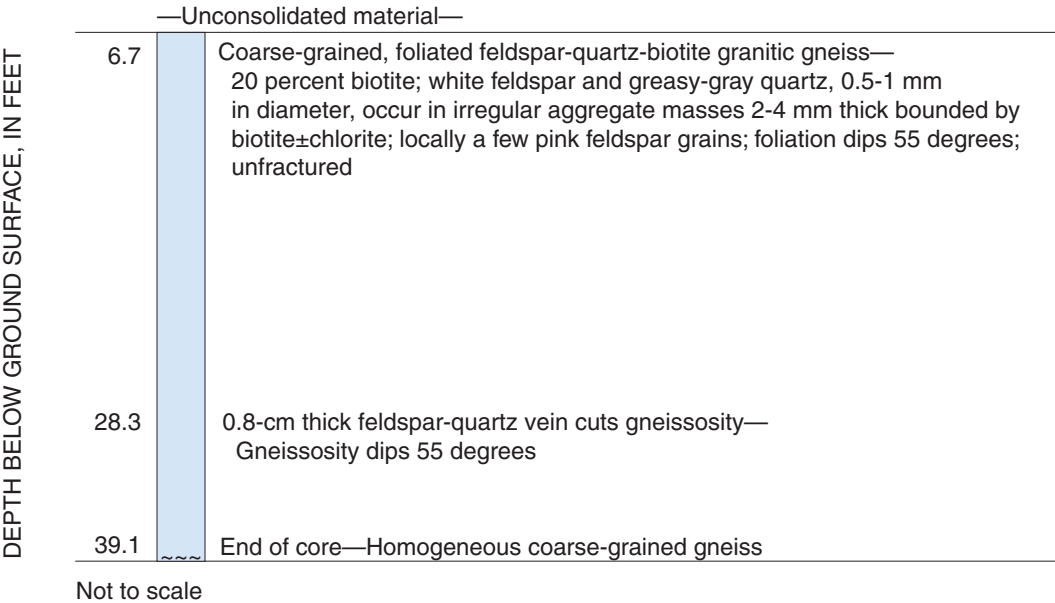
**Figure 1–5.** Core log from borehole at bedrock well MW-9, cell-house site, Berlin, N.H. (See figure 2 for location of well and plate 1 for structure and distribution of rock types.)
